## ULTIMATE AND SERVICE BEHAVIOUR OF GFRP RC BRIDGE DECK SLABS SUBJECTED TO FATIGUE LOADING

## **EFFECT OF CFRP SHEETS ON THE CORRODED STEEL - CONCRETE BOND SUBJECTED TO REPEATED LOADING**

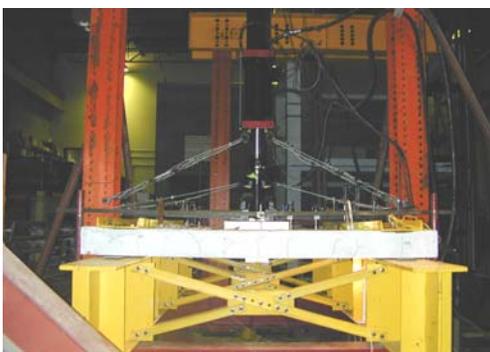
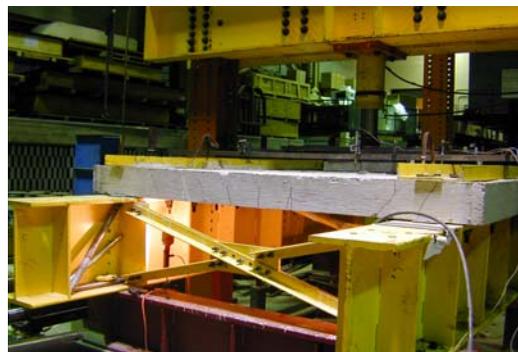
Fig. 1: The test set-up.

The test prototypes were supported longitudinally on two steel girders (built up I-beam section) spaced at 2000 mm center-to-center which were connected together with three cross frames to prevent the lateral movement. To account for the continuity effect in a real bridge, the deck slabs were partially restraint against rotations and lateral displacements. More details about the test set-up can be found elsewhere [10, 11]. All the deck slab test prototypes were tested under a single concentrated load at the center of a clear span of 2000 mm. Figure 1 shows a photo for the test set-up.

a- Cyclic Loading

b- Monotonic Loading.

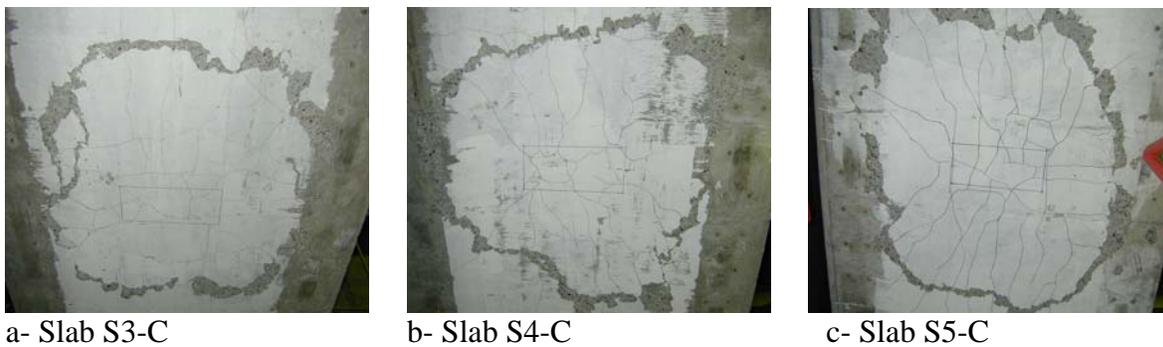
Fig. 6: Comparison of failure shapes and crack patterns on the bottom surface.

All the bridge deck slab prototypes completed successfully the fatigue loading without failure. Then, they failed in punching shear mode under the final monotonic loading step. Figure 6 shows the failure shapes on the bottom surface of three different slabs. The final crack pattern had a flat fan shape. Slab S5-C, which had high bottom reinforcement ratio, had more cracks intensities (the cracks approximately have the same reinforcement spacing).

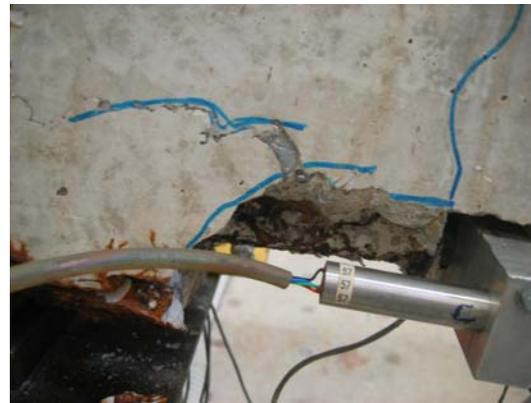
Fig. 3: Typical failure for specimens in G2

The corroded beams in group 2 had longitudinal side and bottom corrosion cracks along the steel bar in the anchored zones before being fatigue tested. In the first 25% to 30% of the beams' life new longitudinal cracks initiated and started to propagate in the anchorage zone and the corrosion cracks widened. Then, the cracks on the surface ceased to lengthen or widen until at about 90% of the beams' life when they started to rapidly increase in length and widen at one end of the beam. This continued until failure. Similar to the un-corroded beams, the failure was sudden and associated by splitting of the concrete cover (Fig. 3).

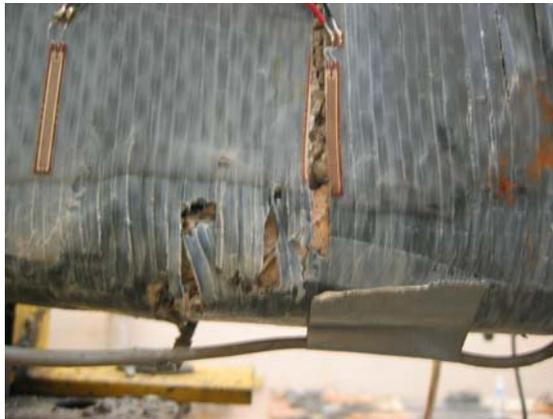
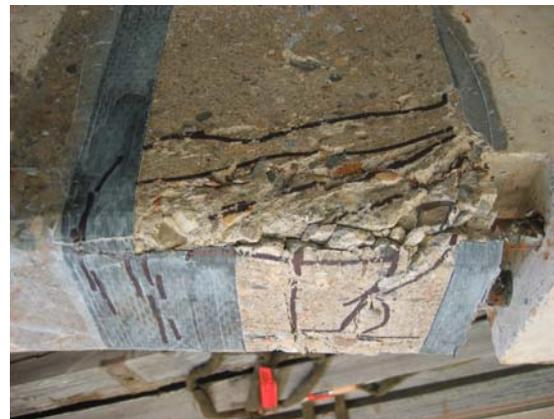
Fig. 4: Typical failure for specimens in Group 3

After the specimens failed, the CFRP sheets were removed, and the concrete cracks in the end zones were inspected. All the wrapped specimens failed in bond. The failure was associated with longitudinal cracks along the steel bars on one side of the specimen. In general these cracks were finer and less numerous than those in the unwrapped beams (Fig. 4).

a) CFRP sheets rupture

b) Concrete splitting

The CFRP sheets in group 3 did not allow monitoring of surface bond crack initiation and propagation. However, it was noted that the failure of these specimens was associated with CFRP sheets rupturing at one end along the plane of the steel bars at one end of the beam.
